Manhole Inspection Summary

Manhole # S21C__031MH

Insp Date: **9/18/07 11:10 AM**

Location Address: **1637 EDMONDSON-ALLEY-FRANKLIN** Cross Street: **MOUNT ST**

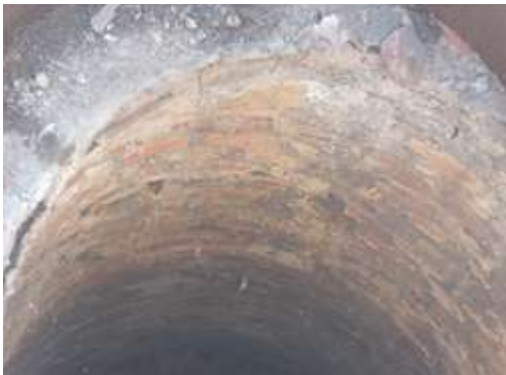
Defect 3

Steps Count: **0** Missing: **5** ☒ **Corroded**

ALL STEPS MISSING

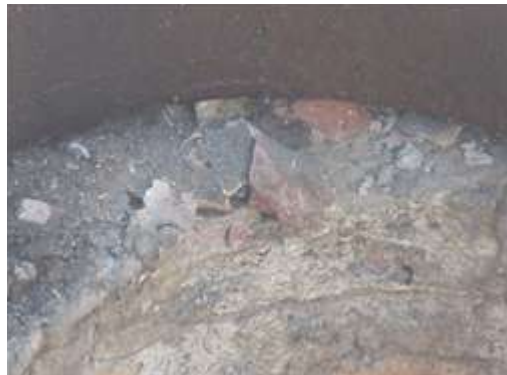
Defect 2

Corbel Material: **Brick** ☐ Parged Type: **Concentric/Eccentric**
Condition: ☐ Sound ☐ Cracked ☐ Root Intrusion ☒ **Loose Brick** ☒ **Deteriorated**
Infiltration: ☒ None ☐ Joint ☐ Cracks ☐ Mortar ☐ Roots ☐ Wall

DETERIORATION OF CORBEL

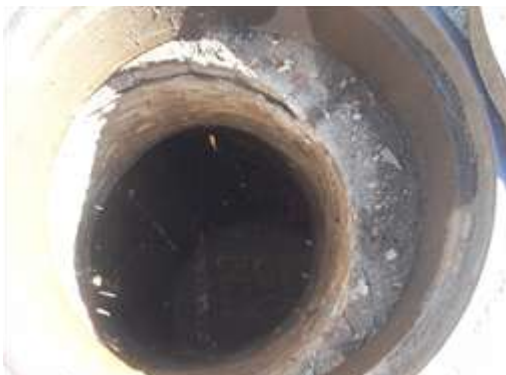
Defect 1

Frame Offset: **6** (in.) Condition: ☒ Sound ☐ Cracked ☐ Leaks

FRAME OFFSET

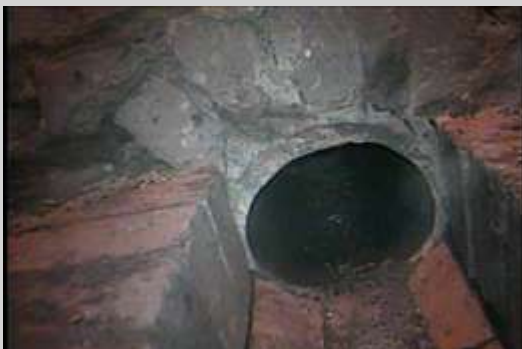
3 O'Clock Inflow

Pipe Height: **6** (in.) Rod and Bar (Angled)
Pipe Material: **Clay** ☐ Pipe Lined
Invert Depth: **8.91** (ft.) Flow Characteristics: **None**
Deposits: ☐ None ☒ **Mud** ☐ Sludge ☐ Debris ☐ Grease
Silt Depth: **1** (in.) Deposits Extent: **Light**
Infiltration: **None** Pipe Seal Cond: **Sound**
